TAUNTON RIVER BASIN  
AVON, MASSACHUSETTS

BROCKTON RESERVOIR DAM  
MA 00786

PHASE I INSPECTION REPORT  
NATIONAL DAM INSPECTION PROGRAM

JANUARY 1980

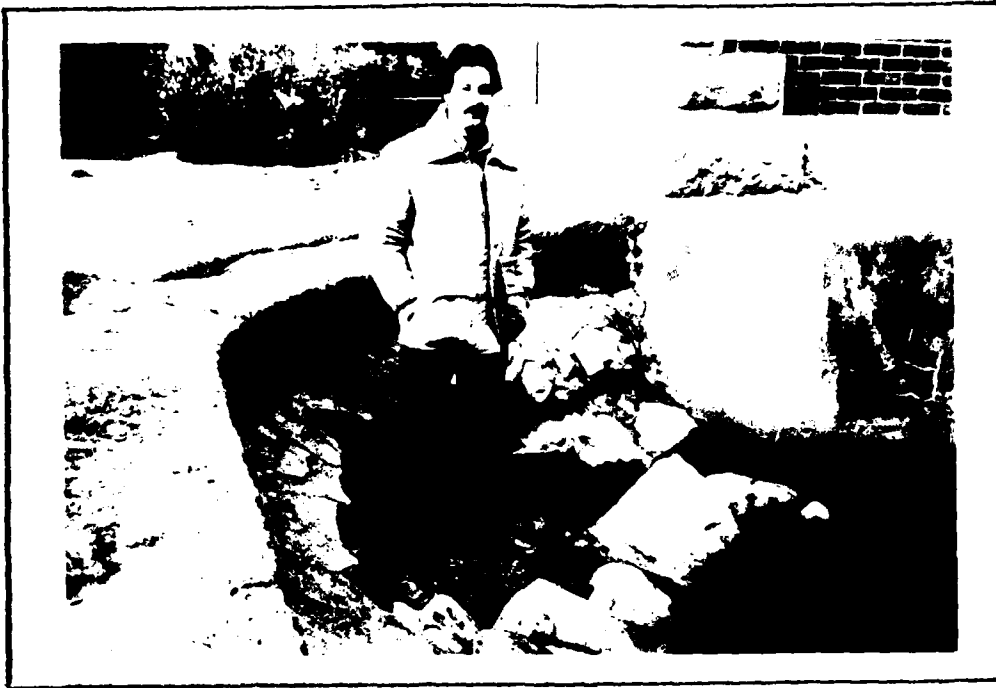
The marshy area noted at the downstream toe of the embankment near the west abutment may be an indication of seepage through the dam, foundation or abutment zone. However, local topography slopes toward this low-lying area and may be indicative of poor drainage of surface runoff. No undulations in the crest or slopes were observed which would indicate embankment instability. The rodent burrows observed on the downstream slope could increase the seepage potential through the embankment. The root systems of the trees growing on the upstream slope could displace the riprap and expose the embankment to wave action.

3. DISPLACED ROCK RIPRAP ON THE UPSTREAM FACE OF THE DAM NEAR THE GATEHOUSE. (10/17/79)

3. Riprap on the upstream face of the dam should be replaced where necessary.

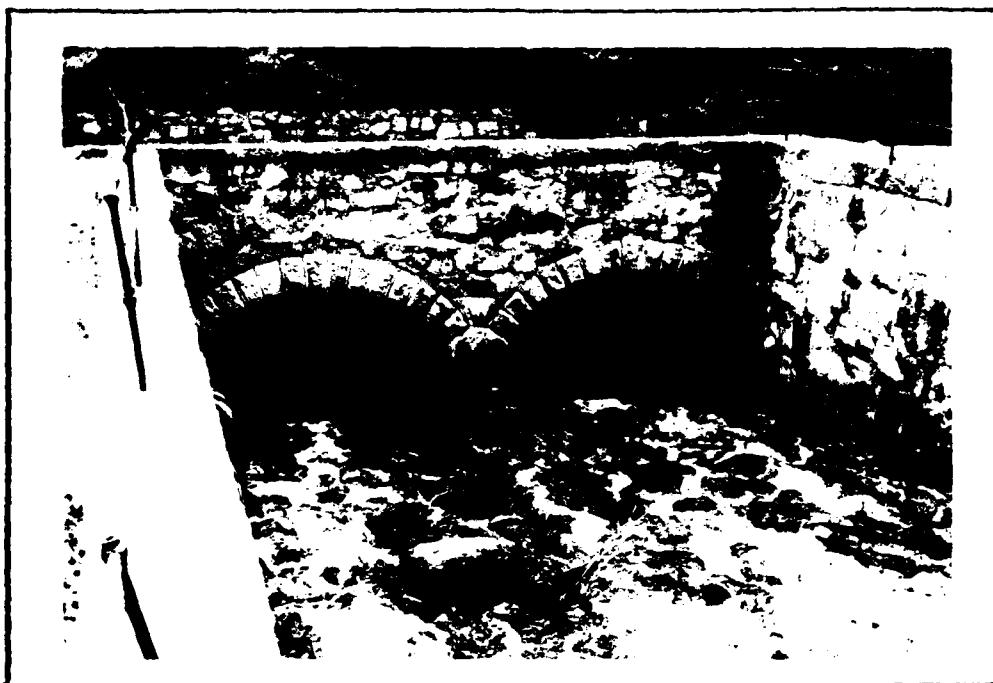
AREA EVALUATED	CONDITIONS
OUTLET WORKS - SPILLWAY WEIR, APPROACH AND DISCHARGE CHANNELS (Con't)	
Loose Rock Overhanging Channel	None.
Trees Overhanging Channel	None.
Floor of Channel	Some displacement of stone blocks.
Other Obstructions	A double arch stone masonry roadway bridge about 30 feet d/s of weir crest.

7. SPILLWAY DISCHARGE CHANNEL IMMEDIATELY DOWNSTREAM OF THE SPILLWAY  
(10/17/79)

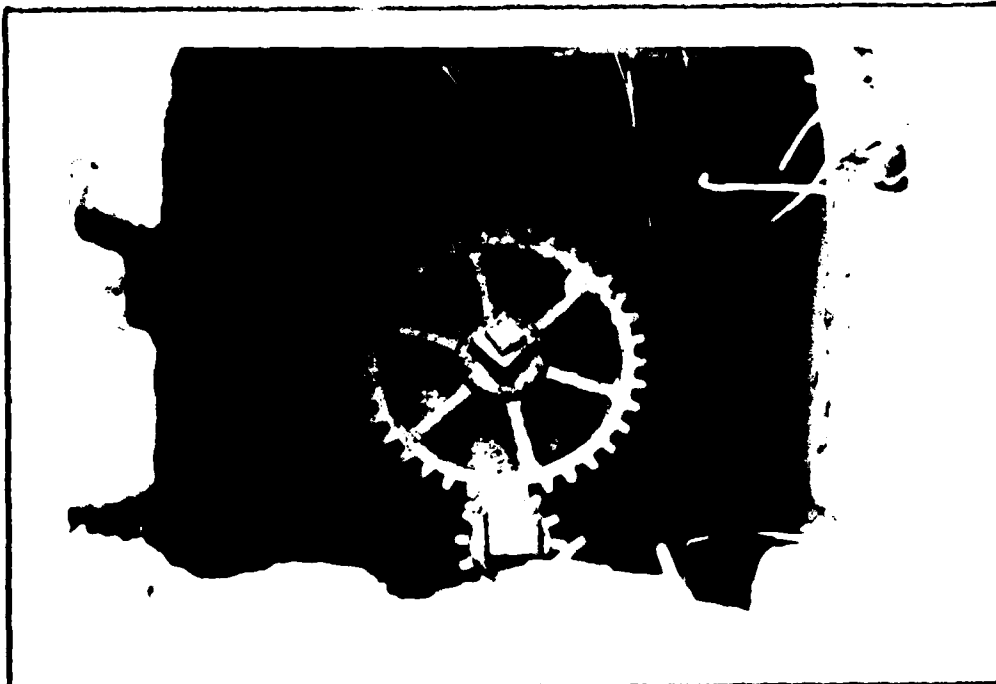
The 20-inch gate valve (invert unknown) located in a stone masonry vault about 30 feet downstream of South Street appeared to be in fair condition. Although the valve key was not available at the time of inspection, Mr. Feroli stated that the valve is operable.

10. VALVE CONTROL ABOUT 100 FEET DOWNSTREAM OF THE GATEHOUSE.  
(10/17/79)
